Portage Creek Sediment Remediation Project Kalamazoo, Michigan

Post-Sediment Removal Structure Feature Assessment Removal Areas SA5-Axtell, SA5-D and SA5-C

F&V Project Number: 809930
October, 2012

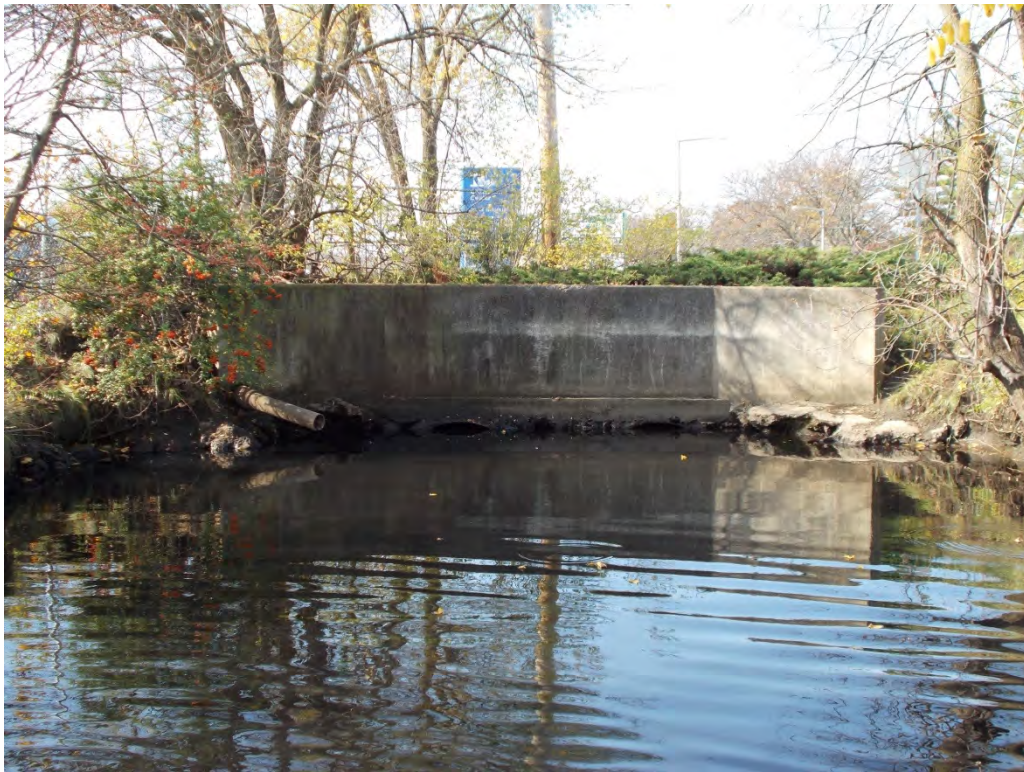
Designation: SA5-Axtell-S01

- The structure does not appear to have been impacted during sediment removal.

Elevation view of the structure

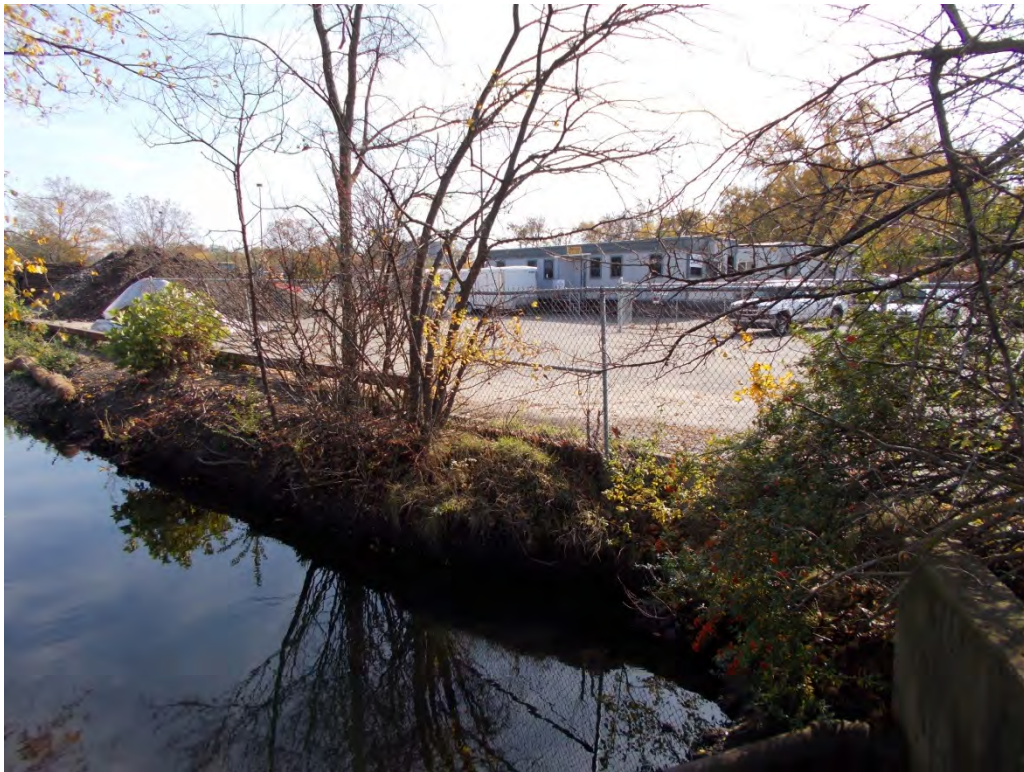
Designation: SA5-Axtell-S02

- The west end of the fence was not removed and does not appear to have been impacted during sediment removal.
- The fencing removed to accommodate sediment removal should be replaced, if directed so by the property owner.

View of remaining fence from the northwest

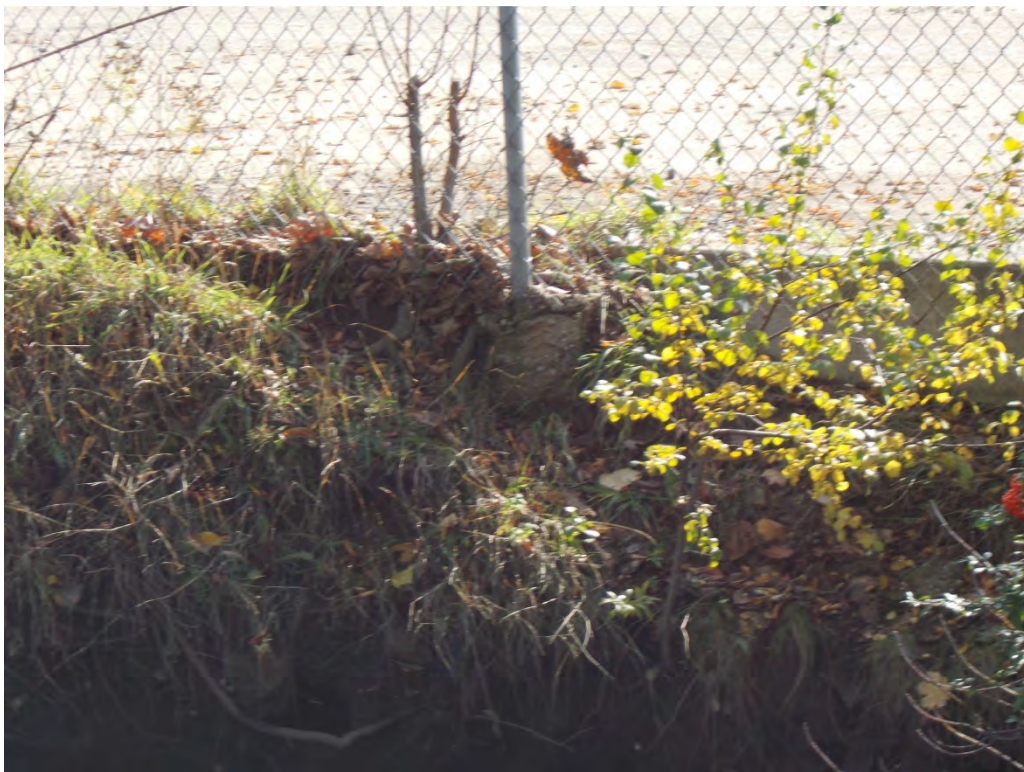
Concrete base exposed by bank erosion

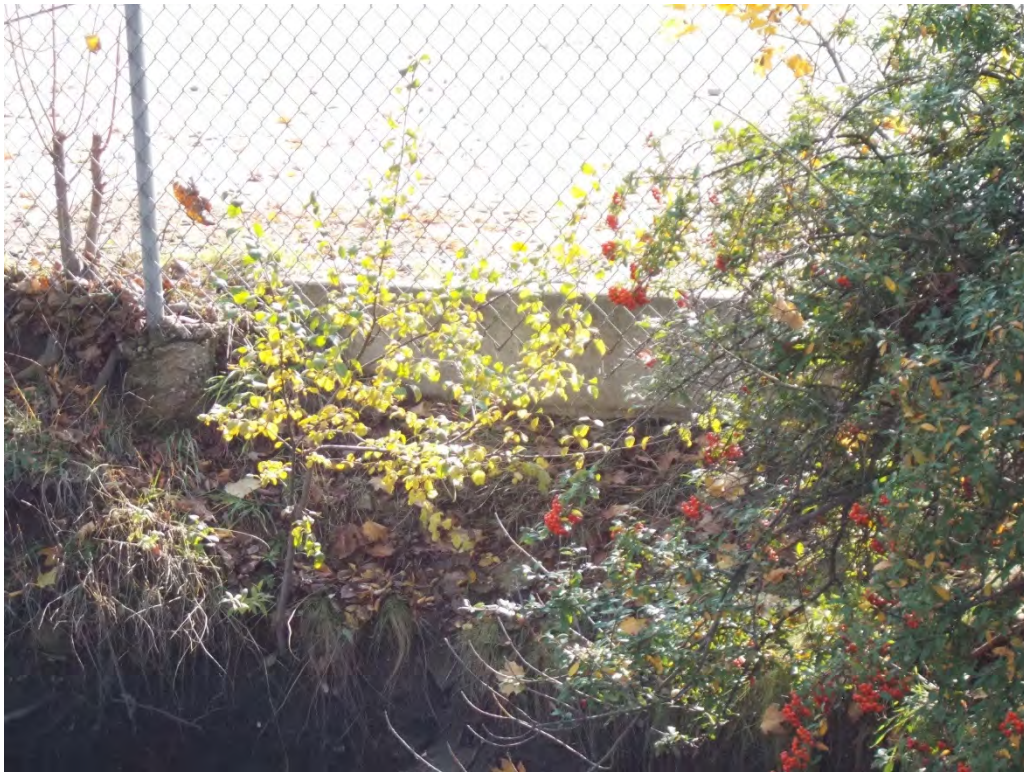
Designation: SA5-Axtell-S03

- Bank erosion along the back of curb appears unchanged.
- The structure does not appear to have been impacted during sediment removal.

Bank erosion exposing back of curb and vegetation growth

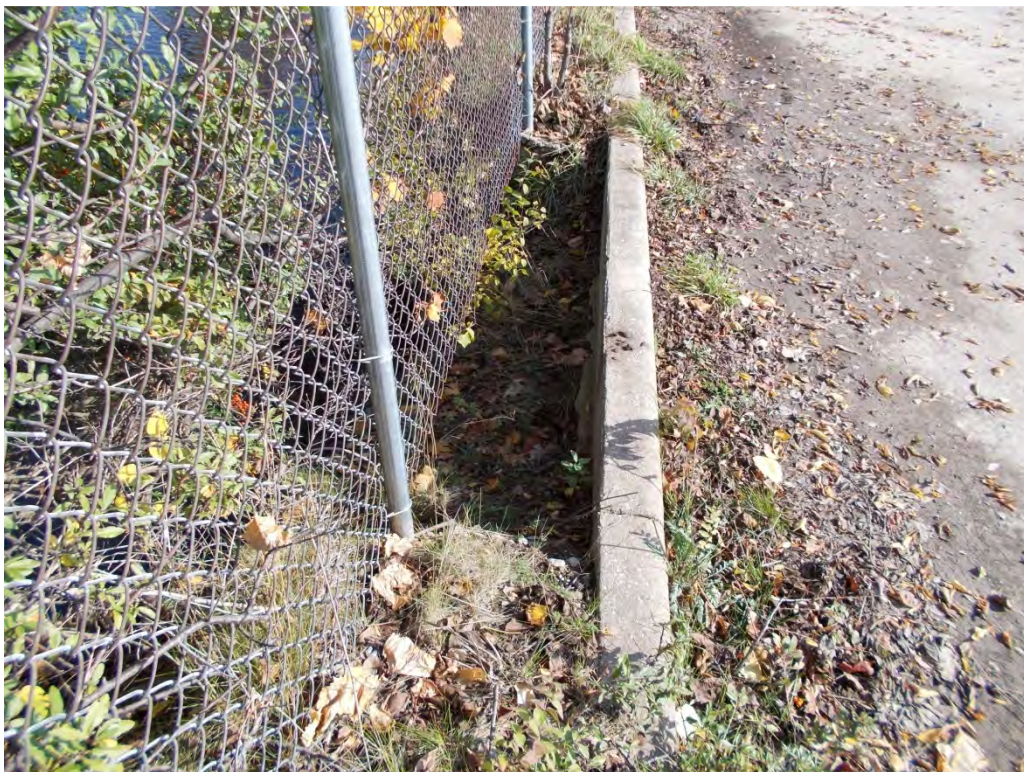
View of bank erosion behind the concrete curb

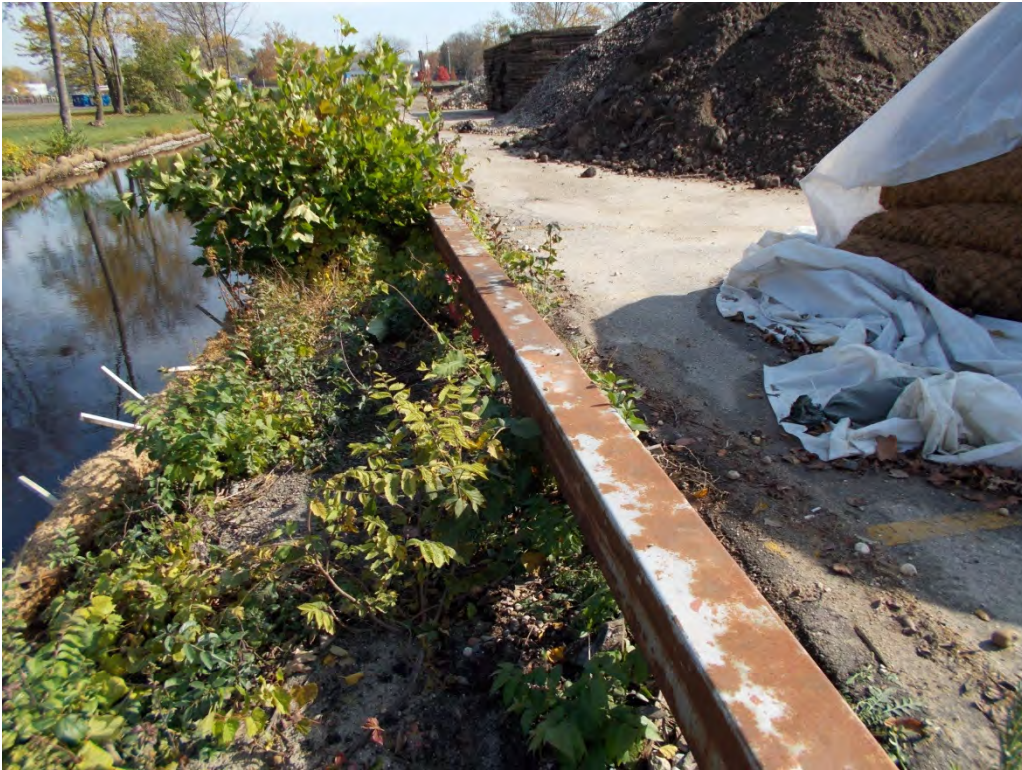
Designation: SA5-Axtell-S04

- There are still several failed section of railing.
- The structure does not appear to have been impacted during sediment removal.

Corrosion on rail looking east

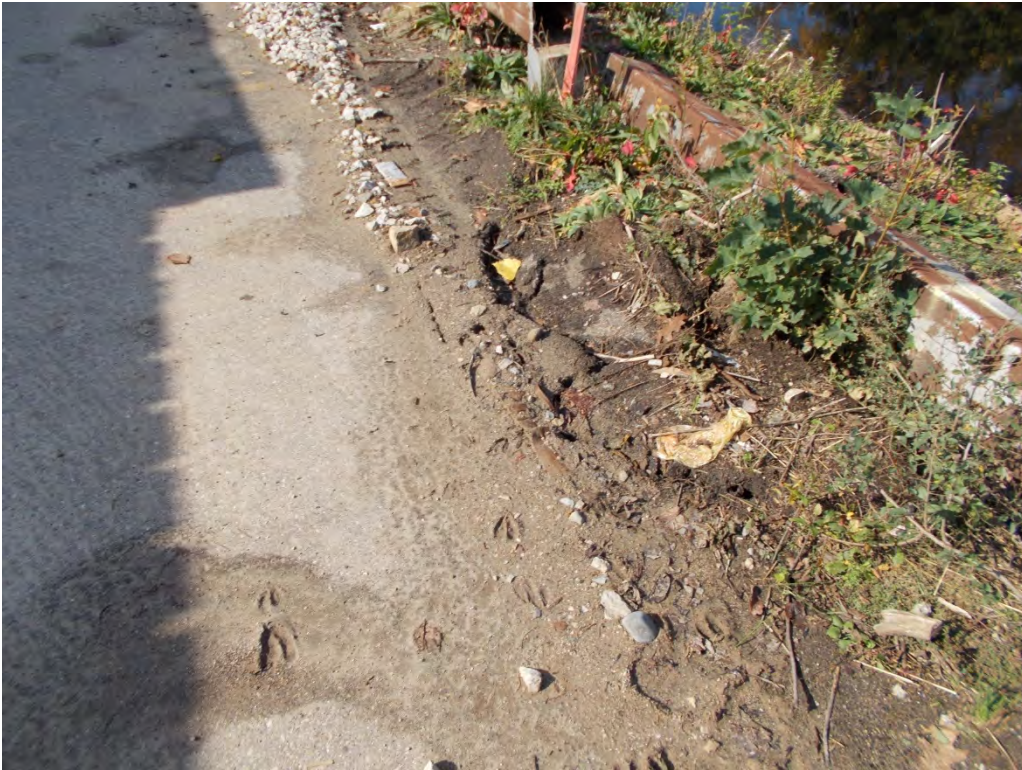
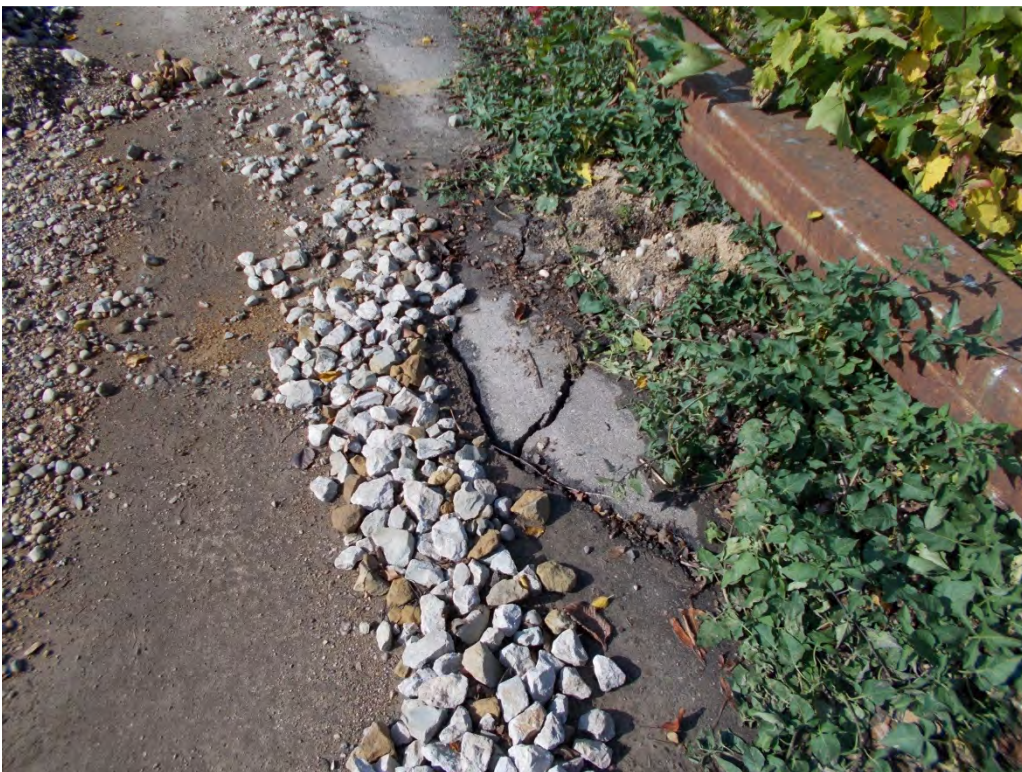
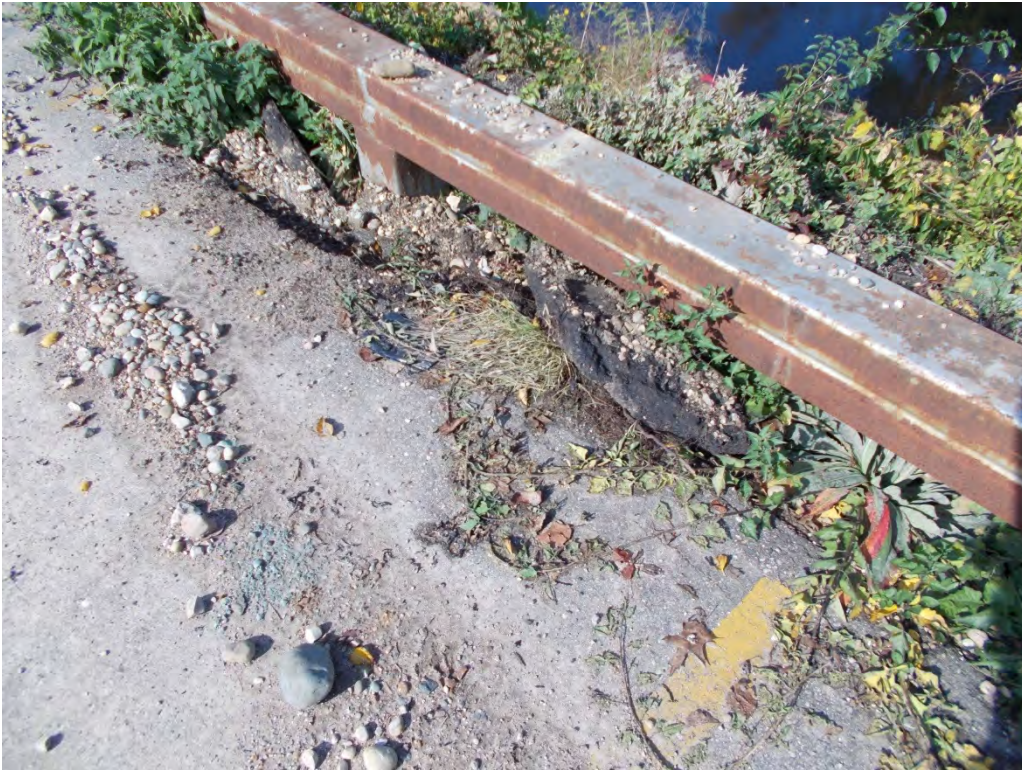
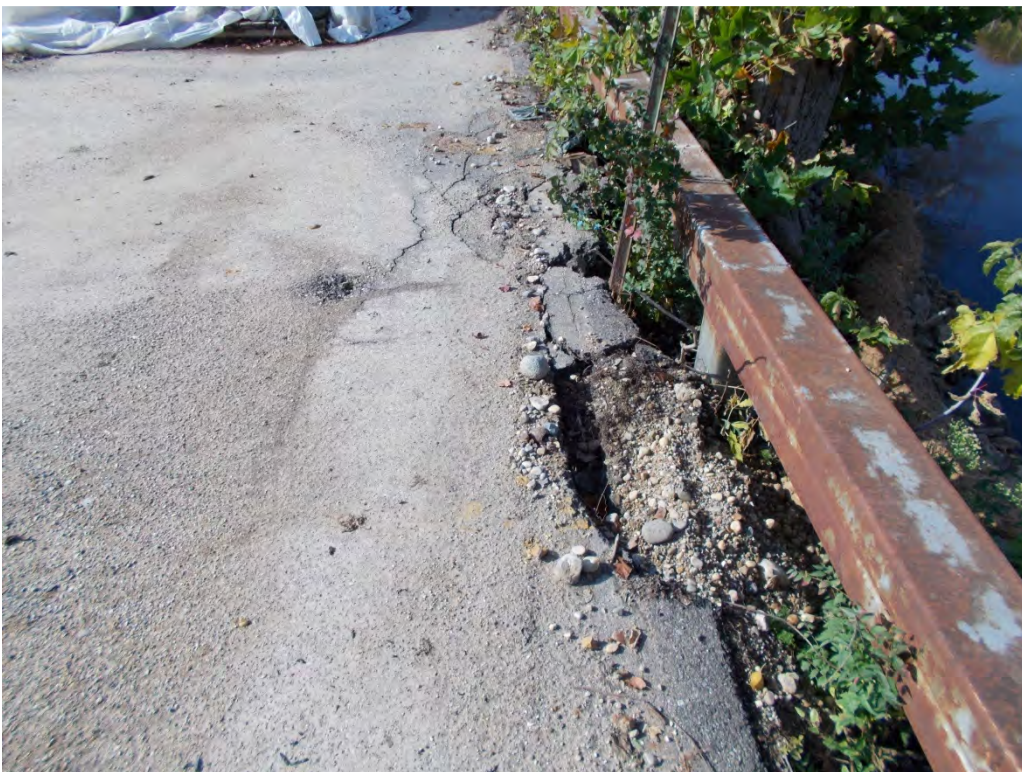
Designation: SA5-Axtell-S05

- The asphalt had significant cracking and minor spalling prior to sediment removal operations, however, cracks appear to have expanded and the edge of the asphalt pavement has significant spalling in several areas.
- Spalled areas should be patched if required by the property owner.

Cracking and edge spalling on asphalt pavement

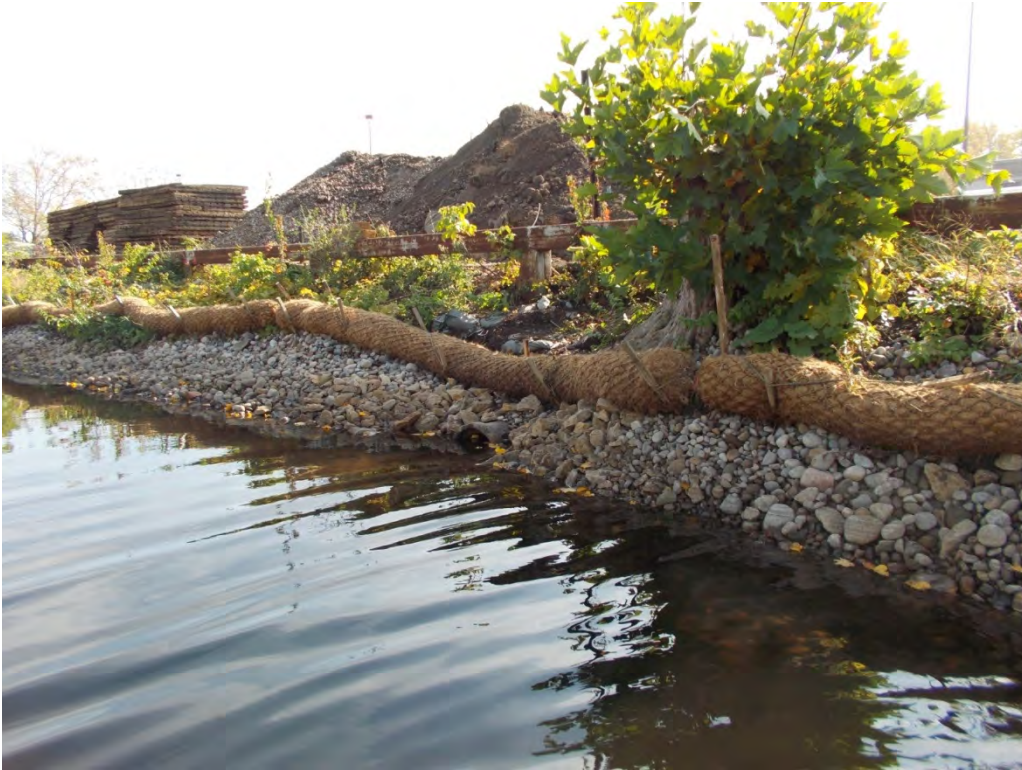
Designation: SA5-Axtell-S06

- The spillway was removed in conjunction with sediment removal, exposing a concrete outlet at the water line. The concrete outlet does not appear to have been impacted during sediment removal.

View of exposed outlet from upstream channel

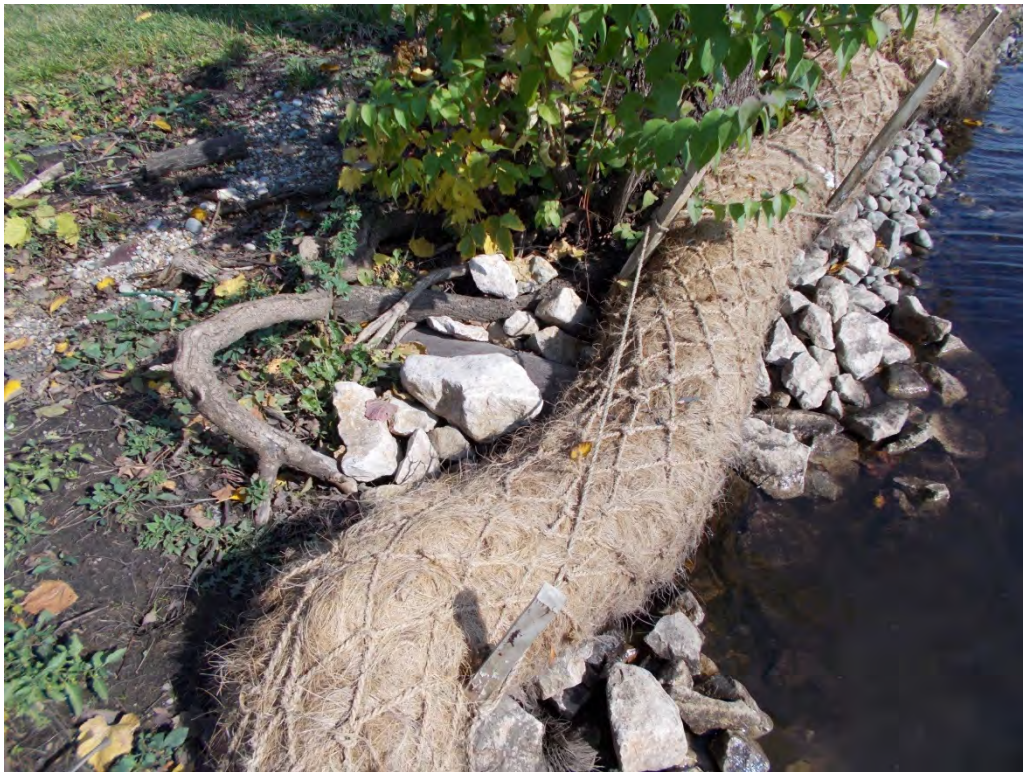
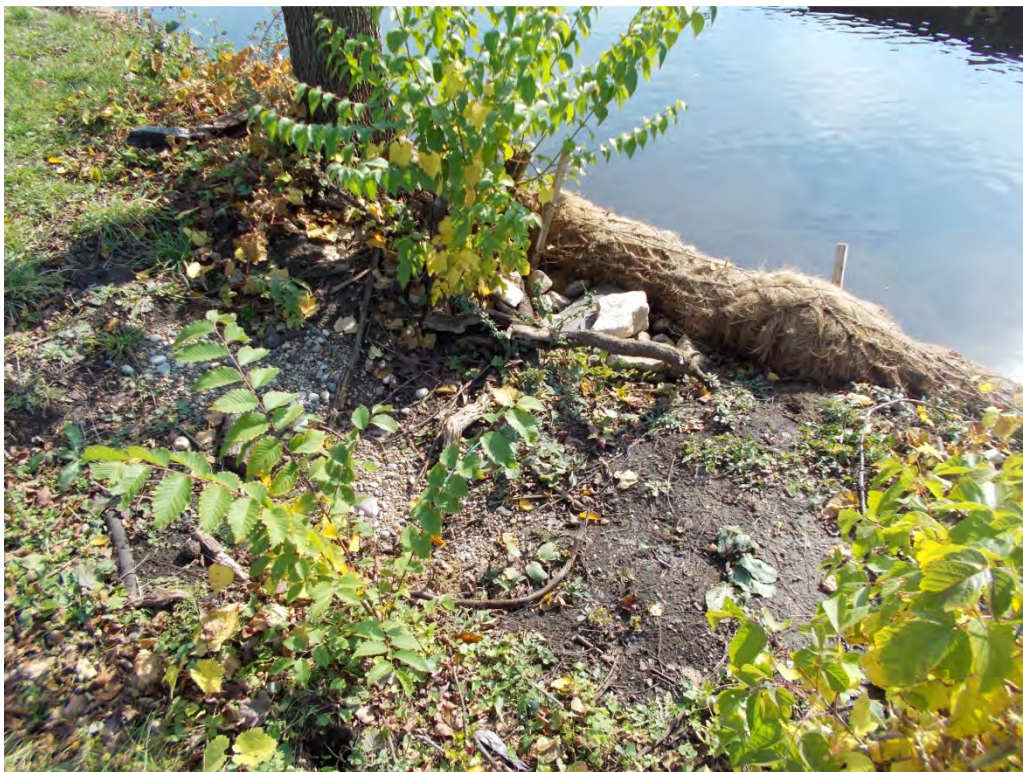
Designation: SA5-Axtell-S07

- Failed end sections were removed in conjunction with sediment removal.
- The remaining structure does not appear to have been impacted during sediment removal.
- The core log has been installed over the outlet and should be adjusted to prevent blockage.

View of the structure from the upstream bank

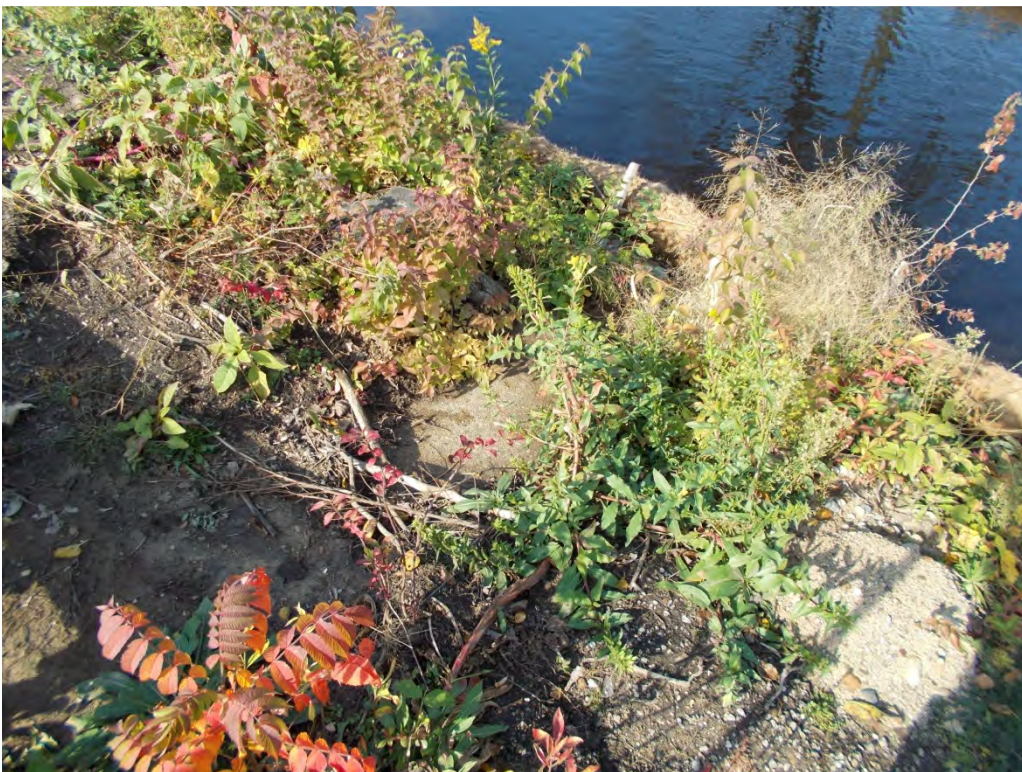
Designation: SA5-Axtell-S08

- The lower section of the spillway was removed in conjunction with sediment removal.
- The upper section does not appear to have been impacted during sediment removal.

Remaining upper section of the abandoned spillway

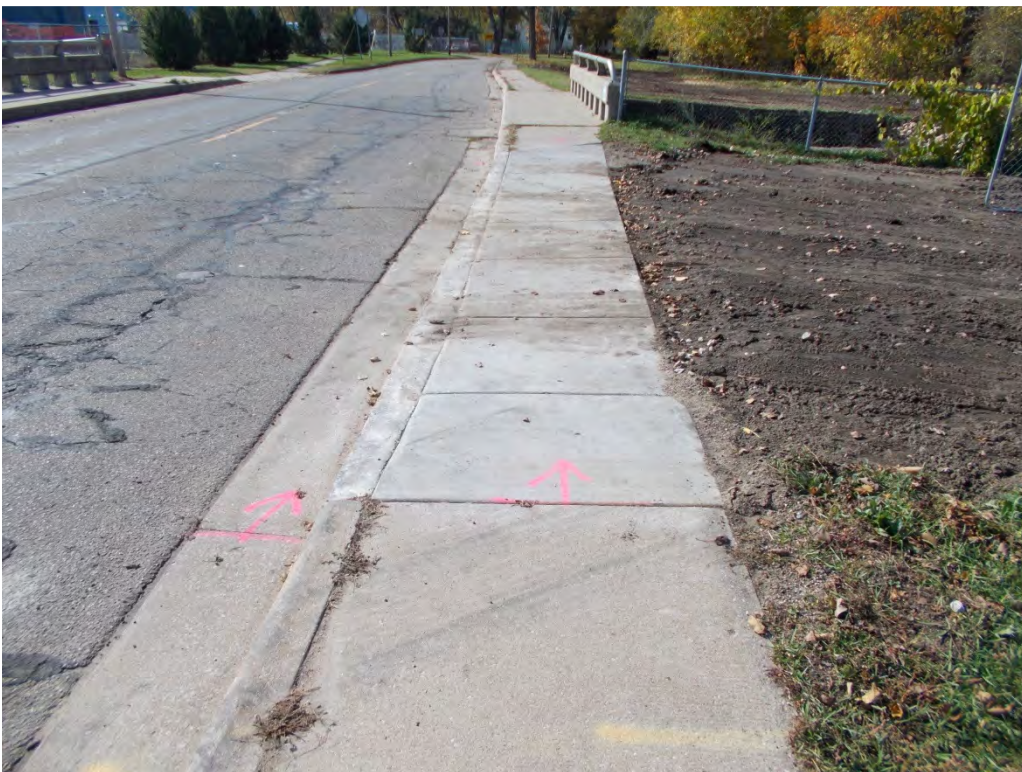
Designation: SA5-D-S01

- The curb head was removed in the northeast quadrant to facilitate access. It and the adjacent sidewalk appear to have been marked for replacement.
- Restoration is required in the northwest and northeast quadrants.
- The fence along the northwest block wall should be replaced.
- The structure itself does not appear to have been impacted during sediment removal.

Curb cut in the northeast quadrant

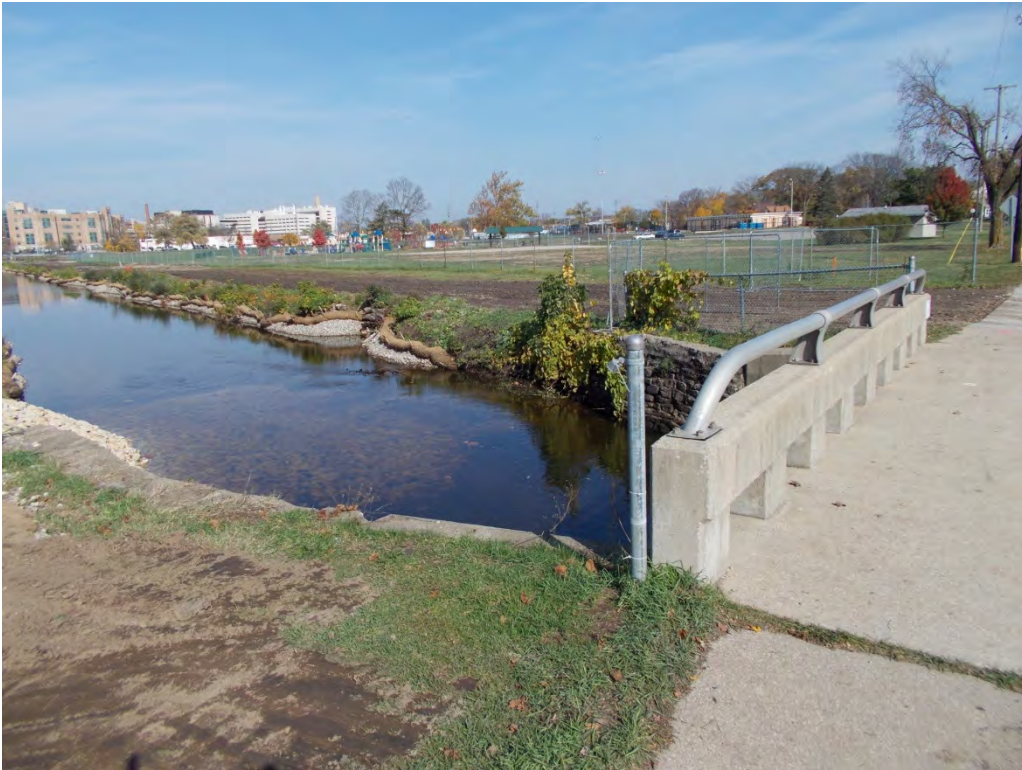
Fence removed in northwest quadrant

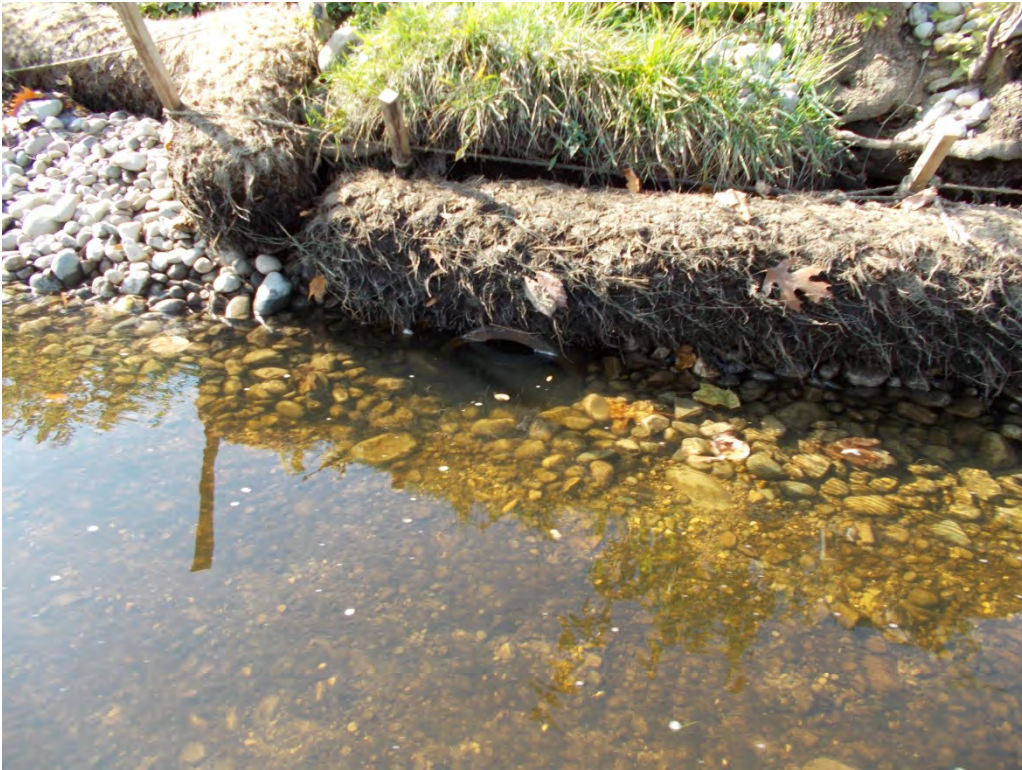
Designation: SA5-D-S03

- The concrete wall has been removed. It functioned as a headwall for a clay pipe outlet at the waterline, which was not visible during prior evaluation. The outlet does not appear to have been impacted during sediment removal.

View of the outlet pipe at the waterline.

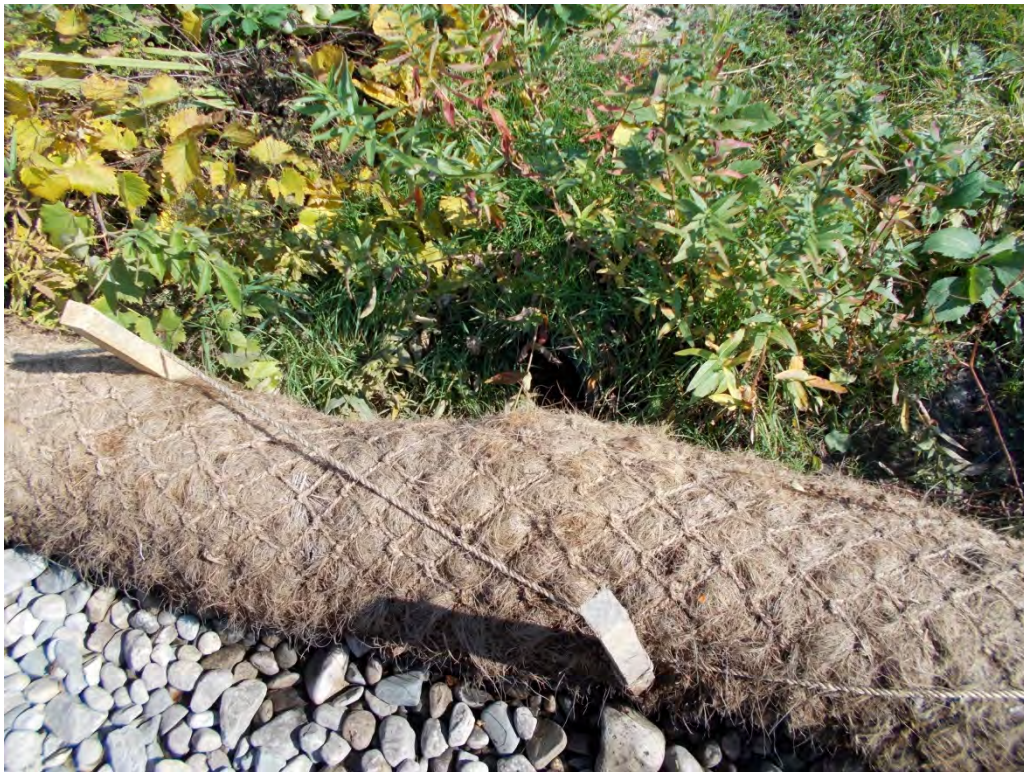
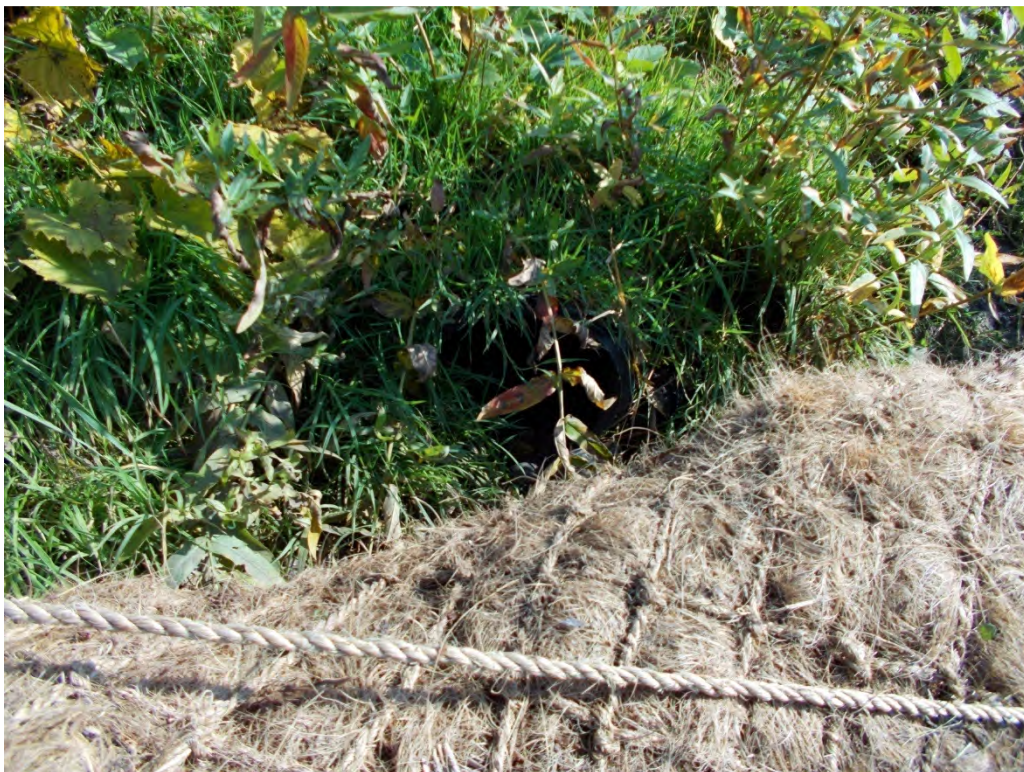
Designation: SA5-D-S09

- The structure does not appear to have been impacted during sediment removal.
- The core log restoration was installed in front of the outlet and should be adjusted to prevent blockage.

View of the outlet from the channel

Small flow of water from outlet

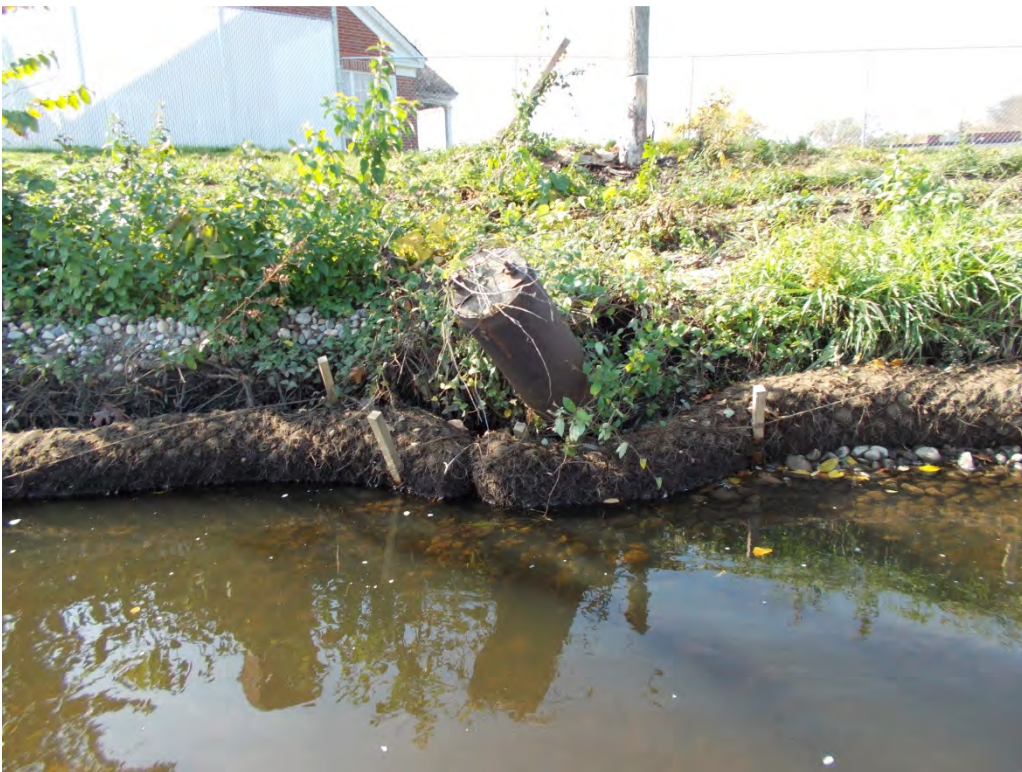
Designation: SA5-D-S10

- The west bollard appears to be leaning toward the channel more than it was prior to sediment removal, however, the structure appears to be abandoned and likely can be left in place.

View of west bollard leaning toward channel area

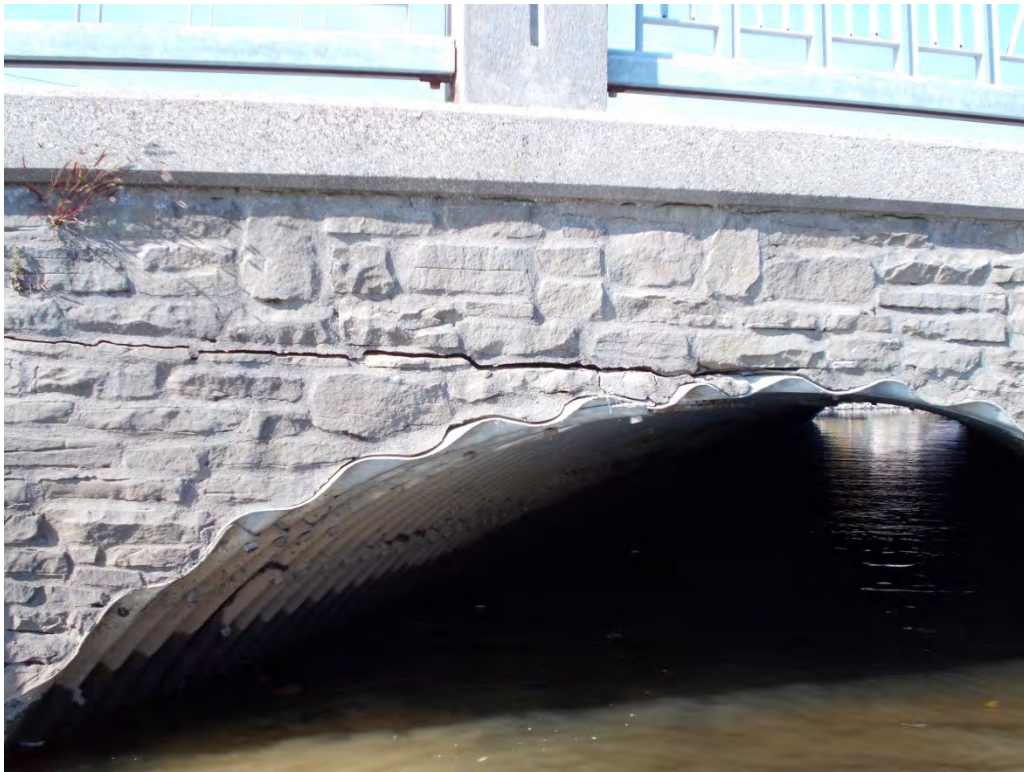
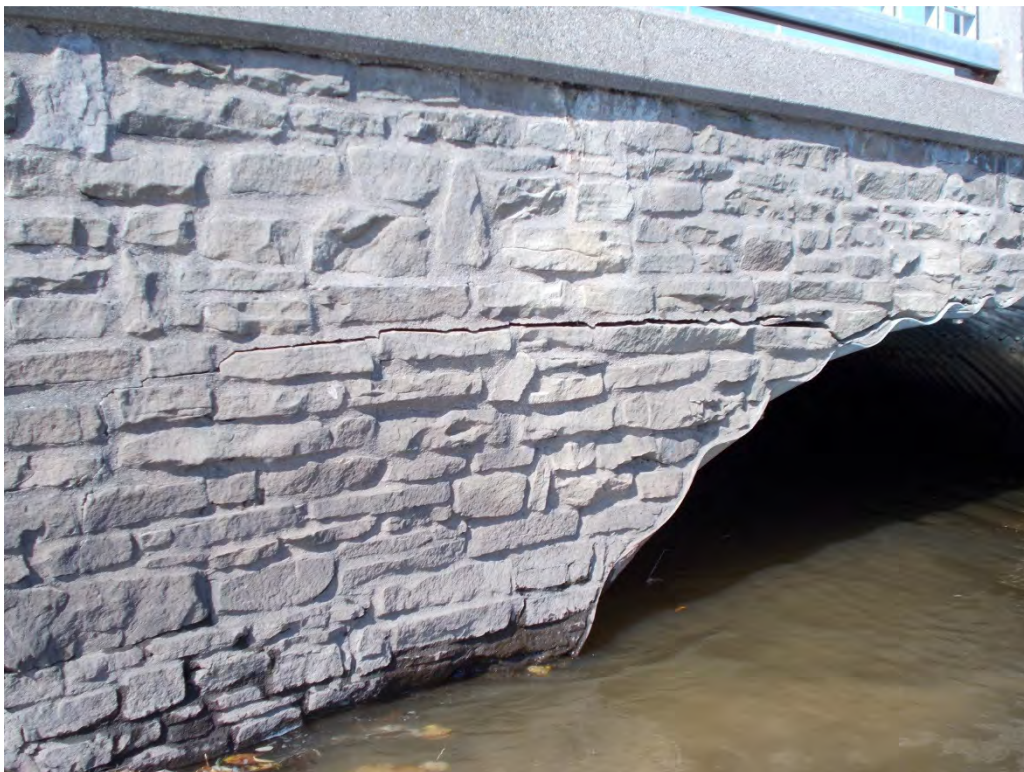
Designation: SA5-D-S13 / SA5-C-S01

- Cracking in the headwalls appears to be unchanged.
- Cracked sidewalk in the southeast and southwest appears to be marked for replacement, as well as a curb cut in the northeast.
- Restoration is required in the southeast, southwest and northeast quadrants.
- The structure itself does not appear to have been impacted during sediment removal.

Headwall cracking appears unchanged

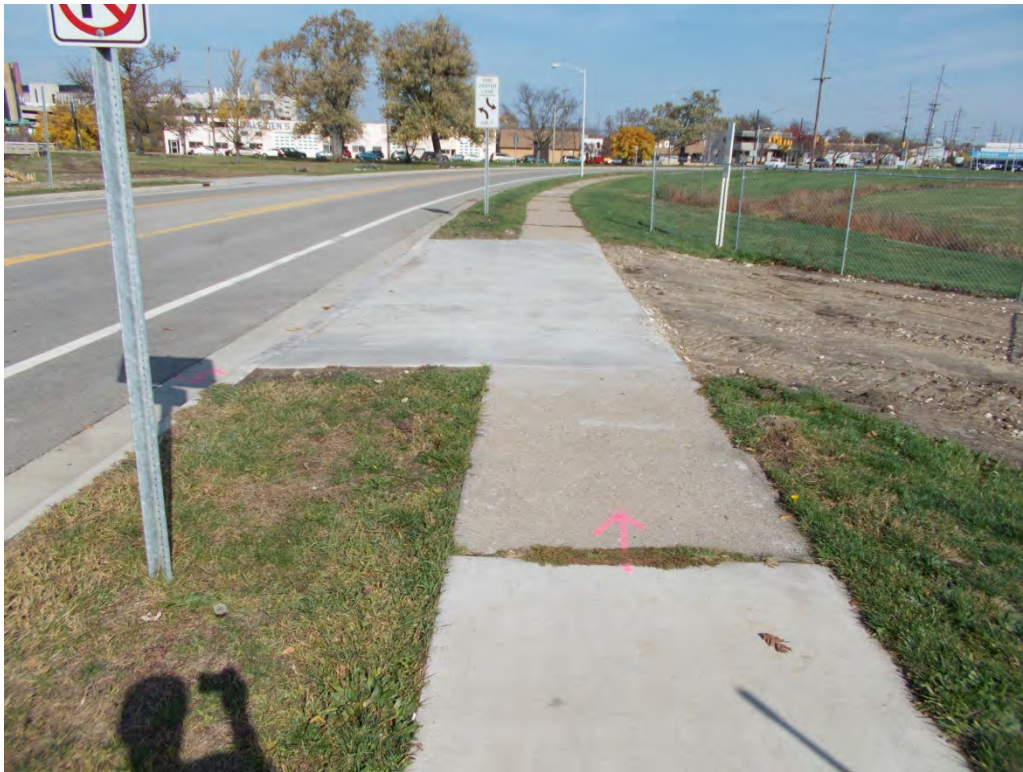
Curb and sidewalk replacement in the southeast quadrant

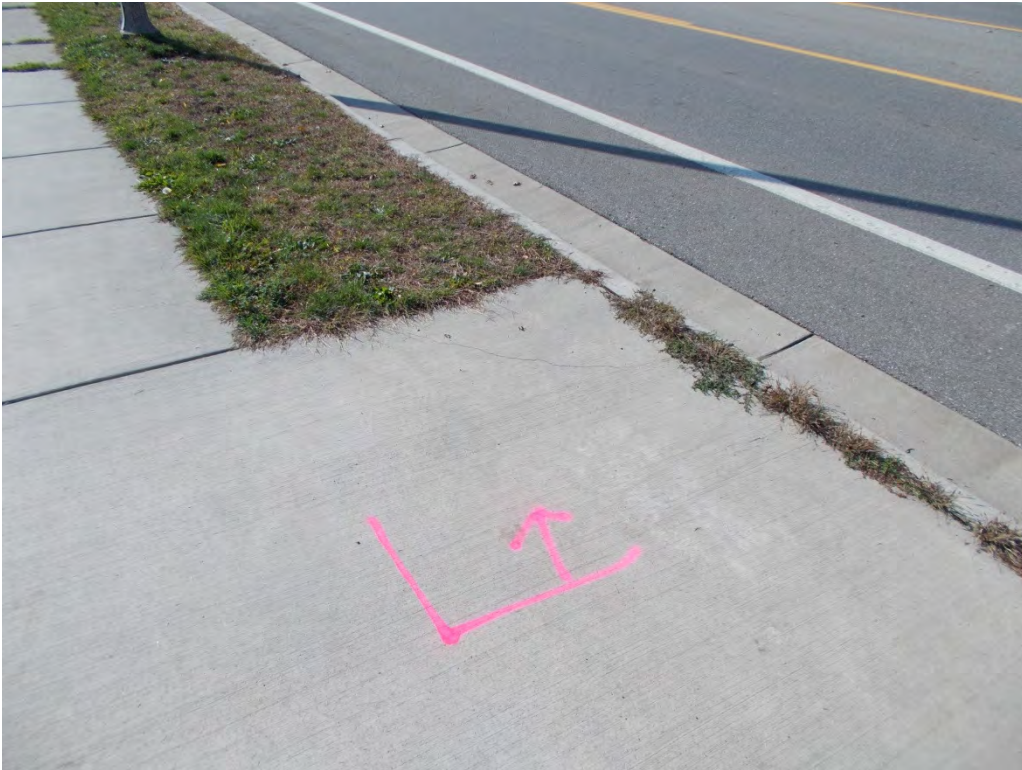
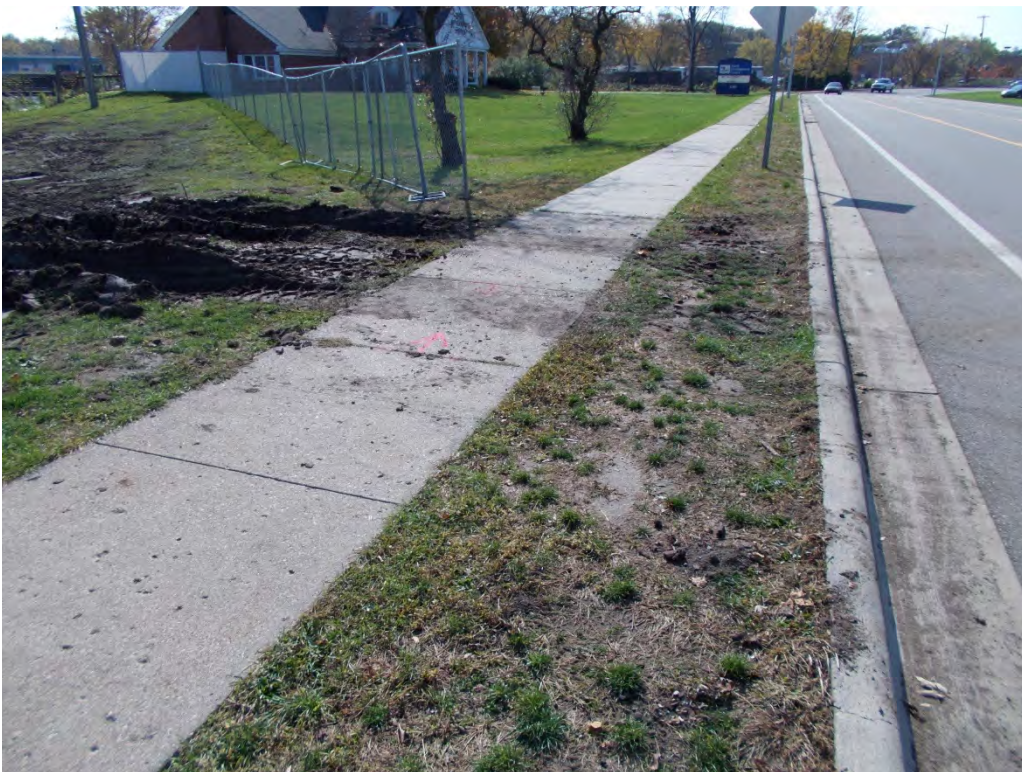
Cracked sidewalk marked for replacement in the southwest quadrant

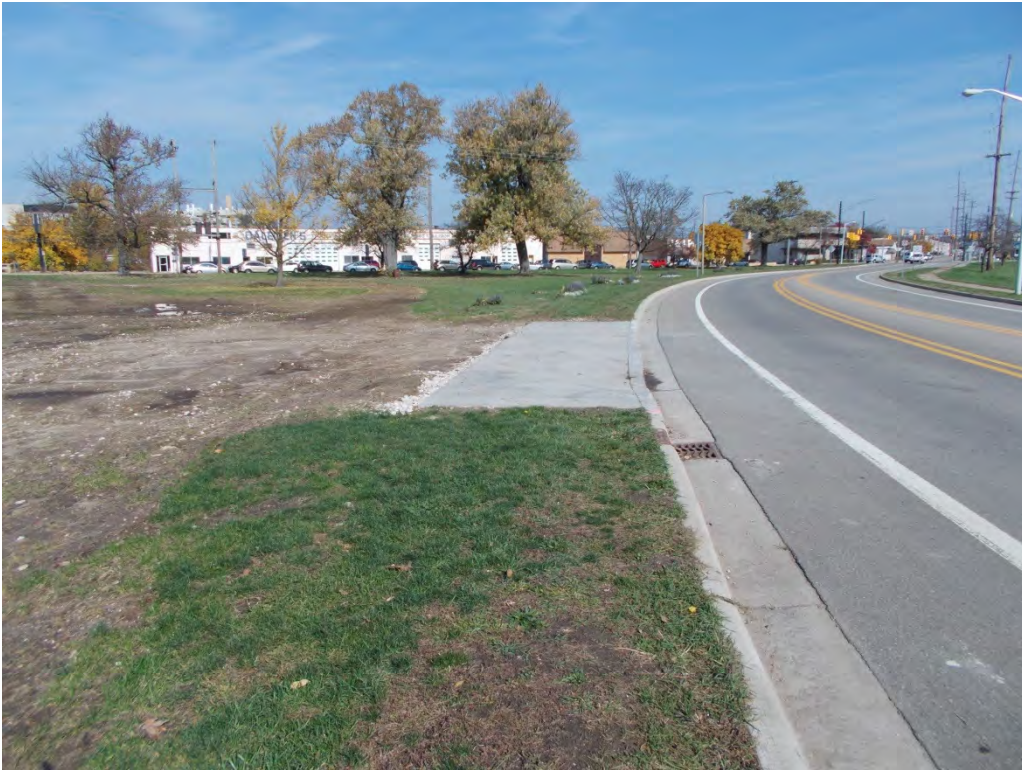
Curb replacement in the northeast quadrant

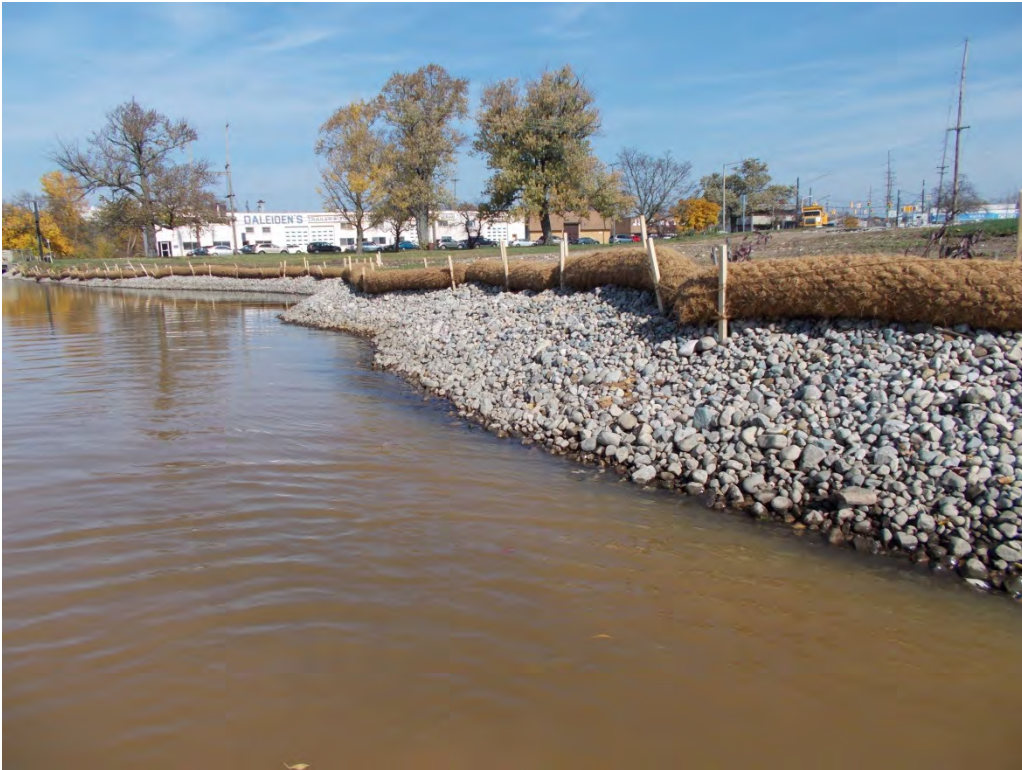
Designation: SA5-C-S04

- The structure appears to have been removed during sediment removal. It could not be located during the evaluation. It should be confirmed that the outlet was abandoned.

Bank restoration in the area of the structure

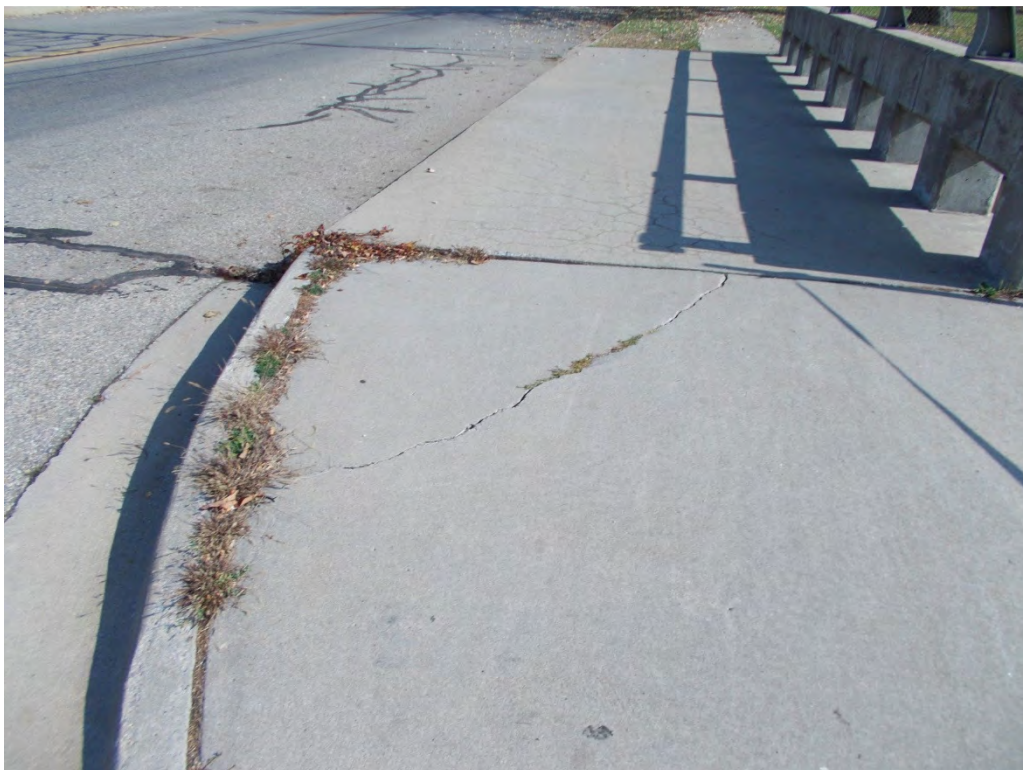
Previous cracking in southwest sidewalk
